TECHNICAL NOTE

D-272

THERMAL-STRESS FATIGUE CRACKING OF TURBINE BUCKETS
OPERATED AT 1700° F IN A TURBOJET ENGINE WITH
LONG PERIODS OF OPERATION BETWEEN STARTS

NATIONAL AERONAUTICS AND SPACE ADMINISTRATION
WASHINGTON

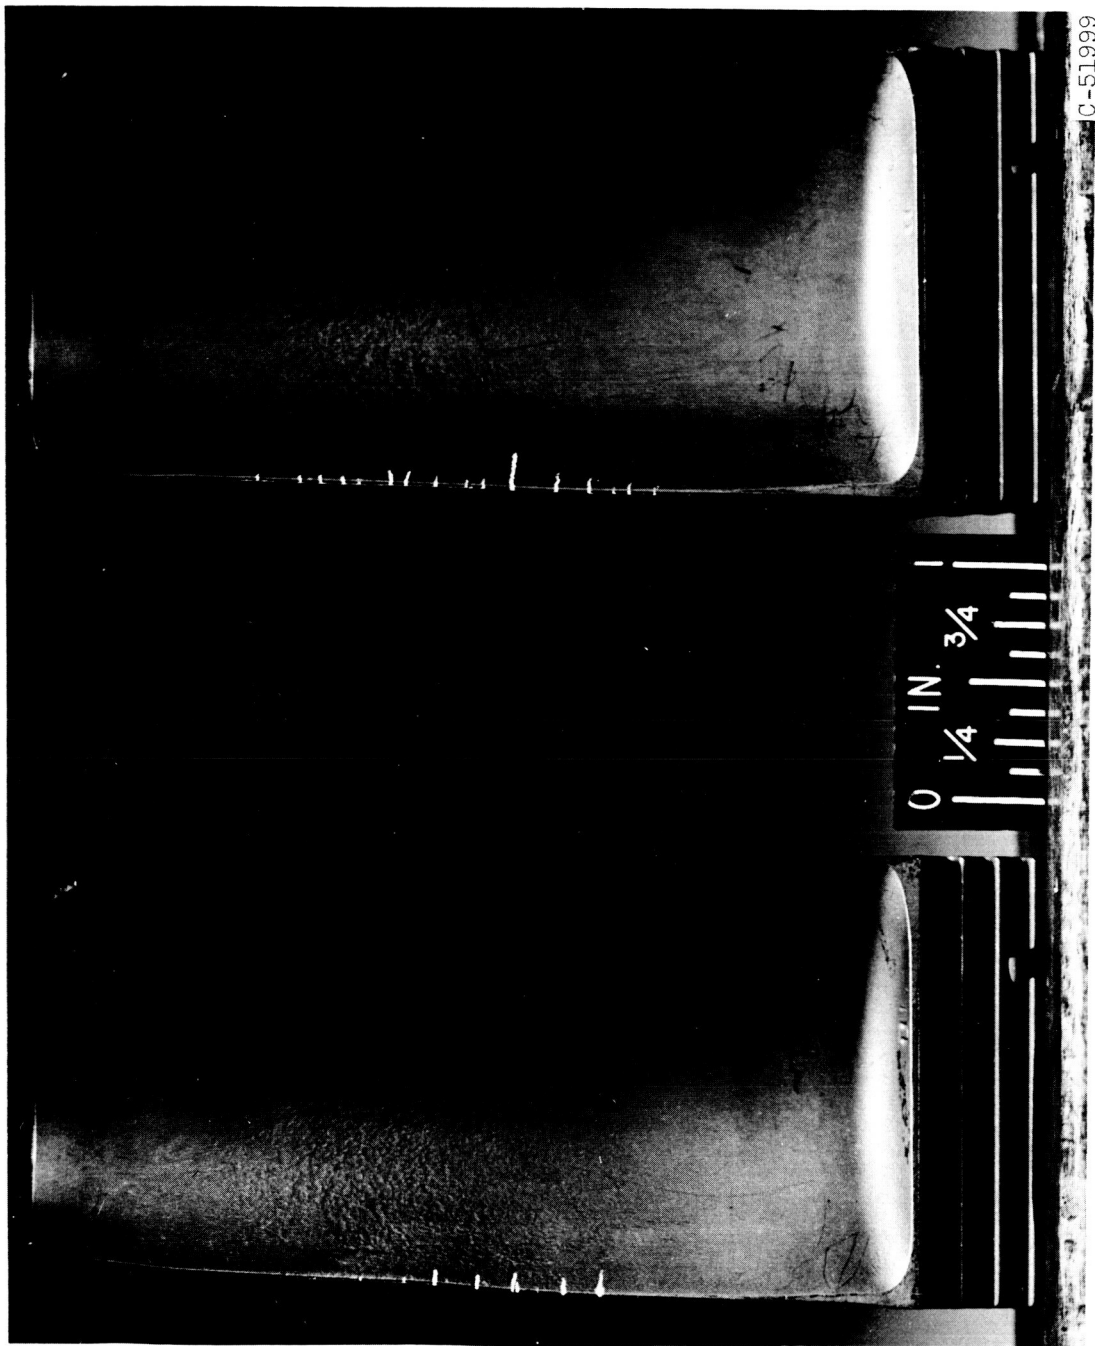
Figure 4. - Typical thermal-stress fatigue cracked buckets.

Thermal-stress fatigue cracking occurred in buckets of all alloy groups. As observed in previous investigations (refs. 1 to 4), these cracks were small and occurred over a considerable length of the bucket leading edge. Typical cracked buckets are shown in figure 4. Bucket failure data are plotted against number of starts in figure 5, since this has been shown (ref. 3) to be the primary cause of thermal-stress fatigue cracking in this engine. The position of each data point indicates the number of starts after which cracks were first observed in each bucket. A nonlinear time scale, showing the hours at rated speed accumulated at each inspection, is also provided for convenience. The figure indicates that no cracking was found after 8 starts and 83 hours at rated speed; however, cracking was noted simultaneously in buckets of all alloy groups after 13 starts and 117 hours at rated speed. More than 50 percent of the buckets of alloys B & B and forged Udimet 500 were cracked at that time. Only four additional starts (total of 17) were necessary to crack more than 50 percent of the buckets of alloy Sel-1. Inconel 713 buckets had a much lower percentage of buckets cracked after a given number of starts. At the conclusion of the test (33 starts and 357 hr at rated speed) from 48 to 100 percent of the buckets in each alloy group had cracked.

Only two buckets, both Sel-1 alloy, fractured during the entire test. Fracture occurred by mechanical-fatigue progression of thermal-stress fatigue cracks. Both of the fractured buckets were initially cracked after 17 starts and 164 hours at rated speed and fractured after 26 and 33 starts (314 and 357 hr at rated speed), respectively.

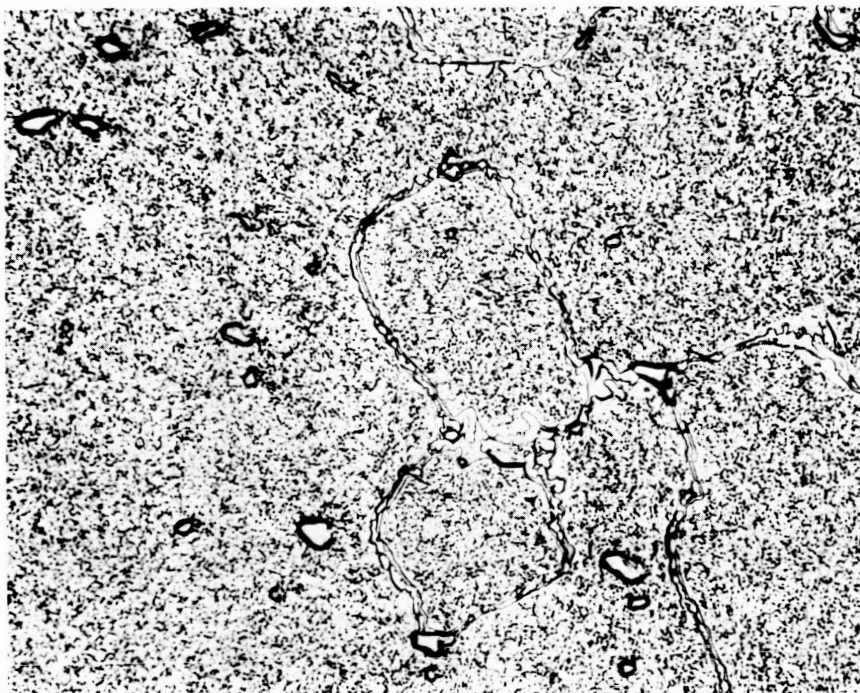
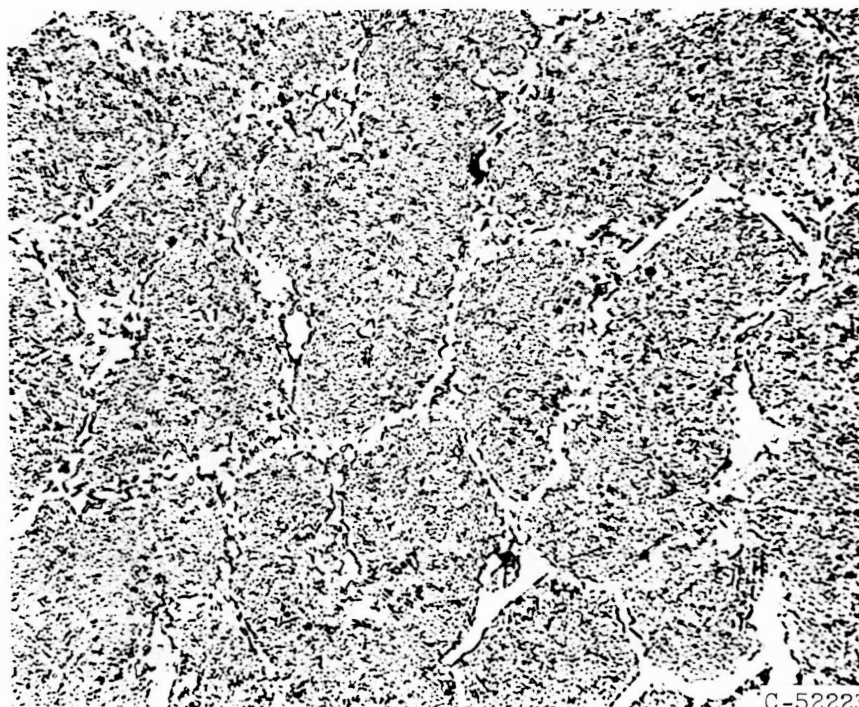
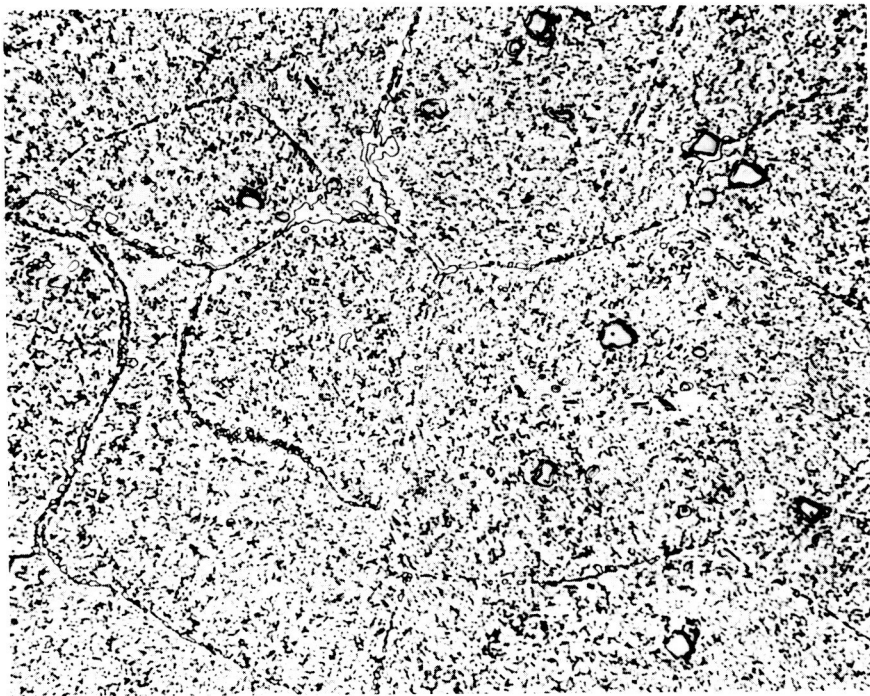
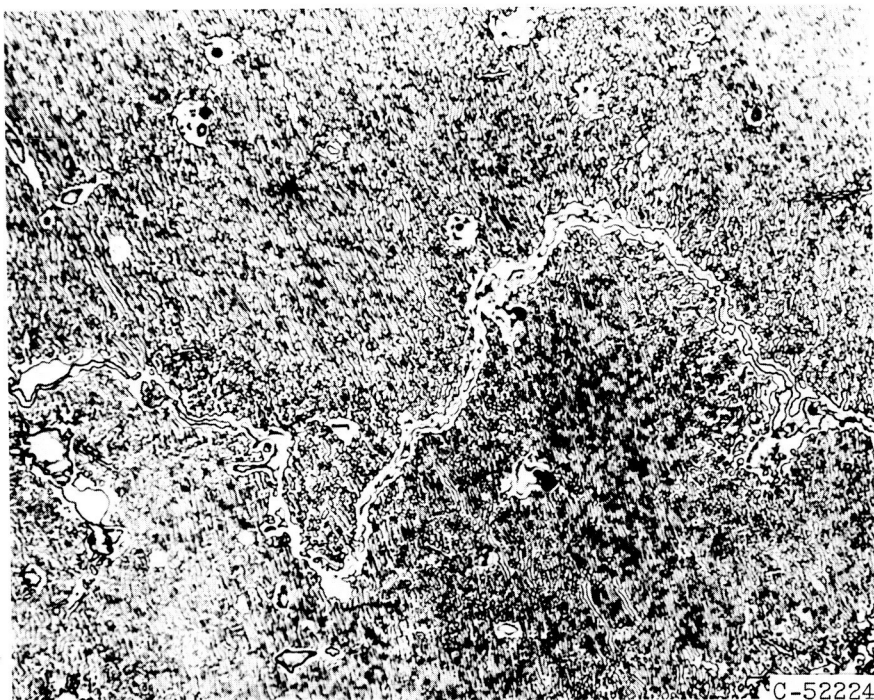
Figure 7. - Typical microstructures of engine operated buckets. Etchant: 10 percent HF, 20 percent HNO_3 . X750.

Photomicrographs of the general structure of buckets of each of the alloys after operation in the engine for the full 357 hours of the test are shown in figure 7. Except for a slight agglomeration of some of the smaller precipitates, the microstructures after the test were almost unchanged from the as-received condition (ref. 4).

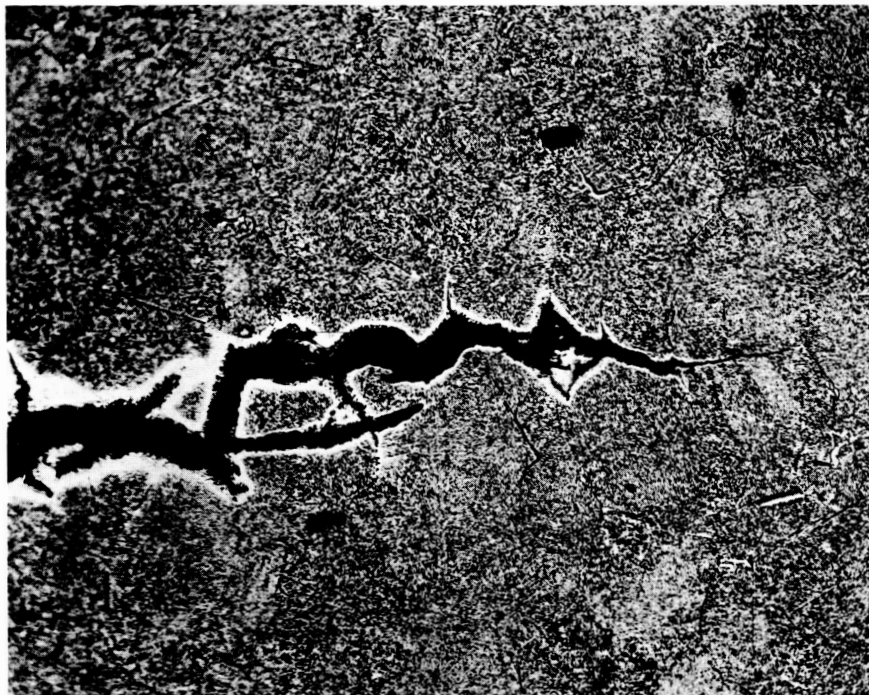
(a) Typical thermal-stress fatigue crack.

Photomicrographs illustrating failed and fractured buckets are shown in figure 8. Figure 8(a) shows a typical crack which has not progressed sufficiently to cause fracture of the bucket. The thermal-fatigue crack appears intergranular, and is similar to the cracks obtained in earlier investigations (refs. 1 to 4). Figure 8(b) illustrates an edge of the failed surface of one of the two fractured buckets. The transition from the rough intergranular crack surface to the smooth transgranular mechanical-fatigue surface is evident. The fracture surface displayed concentric rings, which are indicative of a mechanical-fatigue failure.

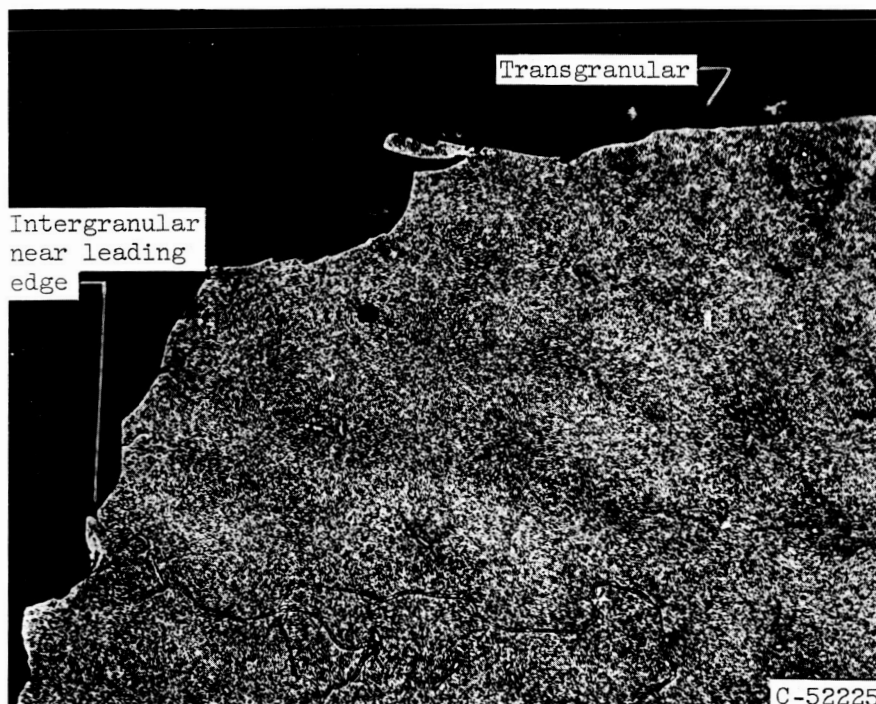
(b) Fracture that was initiated by thermal-stress fatigue and progressed by mechanical fatigue.

The mode by which cracks progressed to cause fracture of buckets apparently was not affected by the increased time of rated-speed operation between engine starts. The two buckets that fractured, both Sel-1, did so by mechanical-fatigue progression of a thermal-stress fatigue crack, the same mechanism encountered in previous investigations (refs. 1, 2, and 4). The two buckets were initially cracked after 164 hours at rated speed and ran an additional 150 and 193 hours, respectively, before fracture occurred.
